ASSESSMENT AND PRESERVATION PLAN  
FOR GLENWOOD CEMETERY,  
THOMASTON, GEORGIA

Prepared By:  
Michael Trinkley, Ph.D.  
and  
Debi Hacker

May 22, 2001

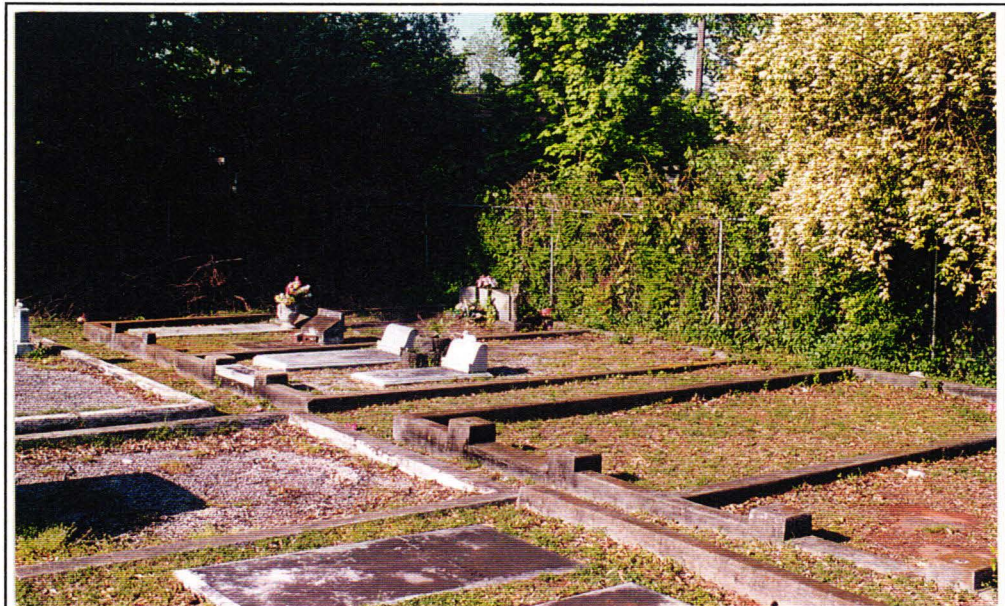
Figure 43. Area of fence showing drastic and inappropriate pruning. A revegetation effort is needed (see also Figure 44).

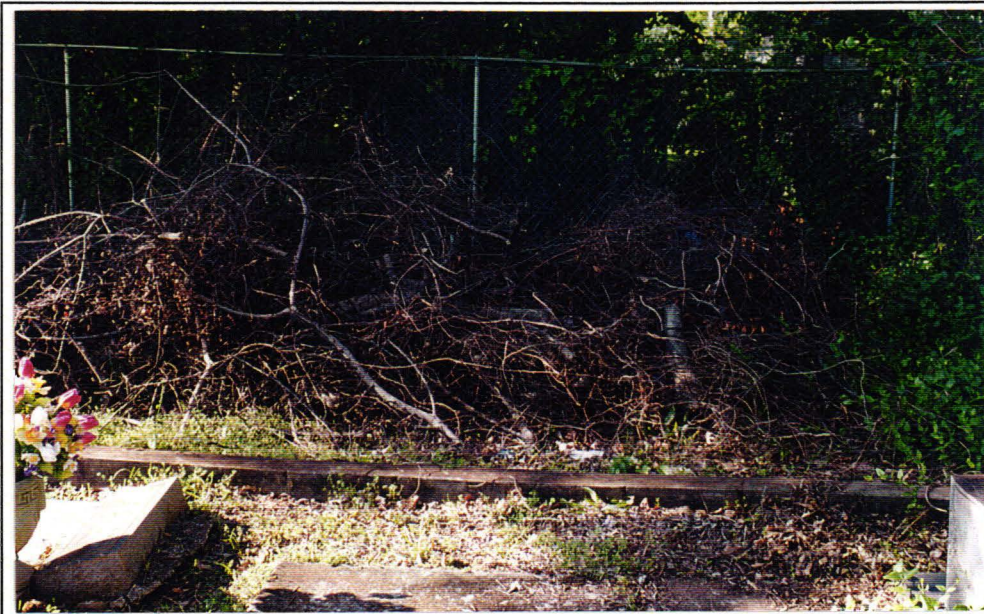
Figure 44. Debris from the improper trimming (see Figure 43) have been piled on a grave. These debris, left for at least several months, need to be immediately removed. This sort of behavior cannot be tolerated and those responsible should be identified.

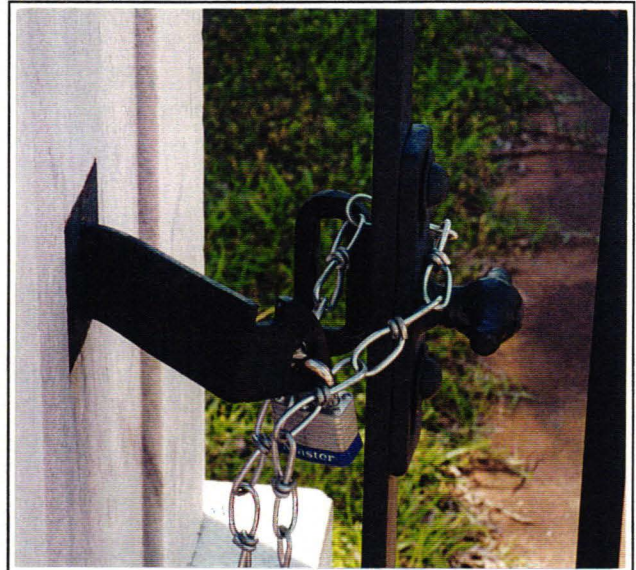
Figure 45. Example of bent hasp on a pedestrian gate at Glenwood. Rather than appropriately fix the damage, the City has used swing chain to lock the gate. This is an example of inappropriate maintenance that degrades the beauty and dignity of the cemetery.

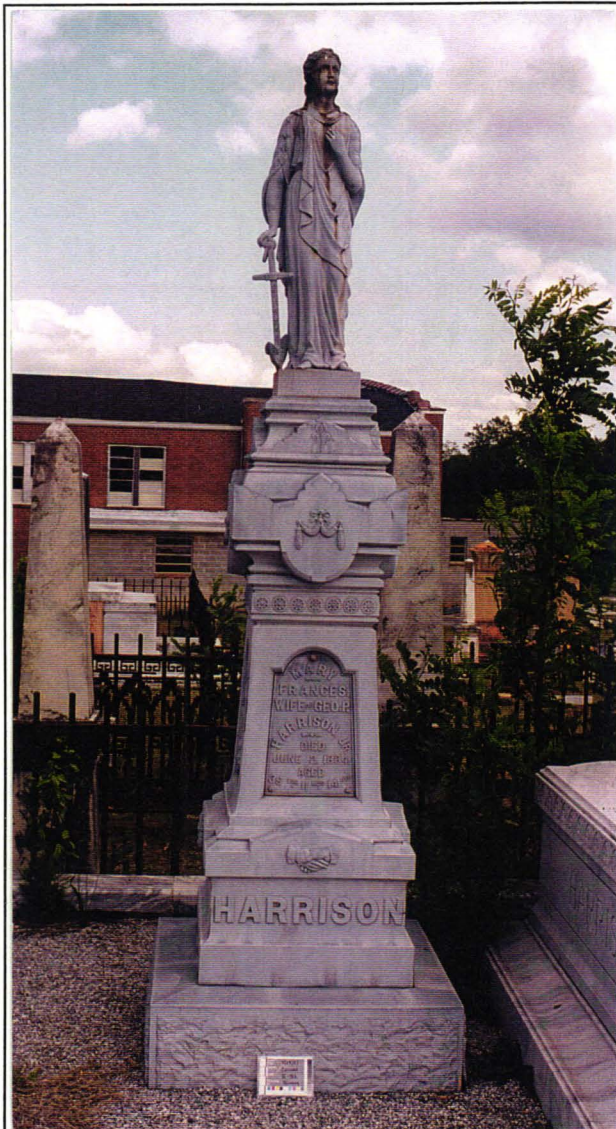
Figure 46. Zinc monument at Glenwood (II-32k). Note the staining at the head.

- The one zinc monument at Glenwood exhibits evidence of cracking and deterioration cause by "creep" of the metal. Repair will be costly and may be delayed for 5 to 10 years to allow the funds to be collected. Postponing treatment longer will result in irreparable damage to this unique monument.

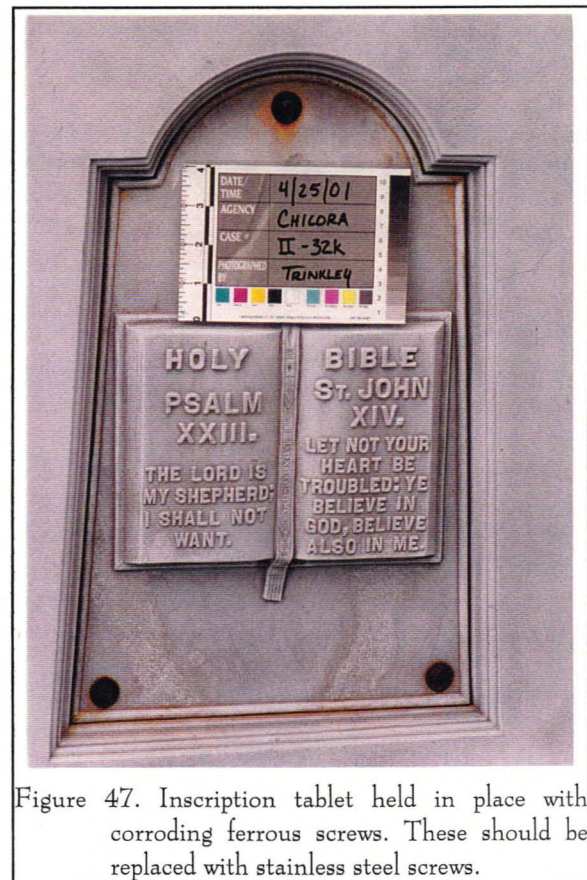
Figure 47. Inscription tablet held in place with corroding ferrous screws. These should be replaced with stainless steel screws.

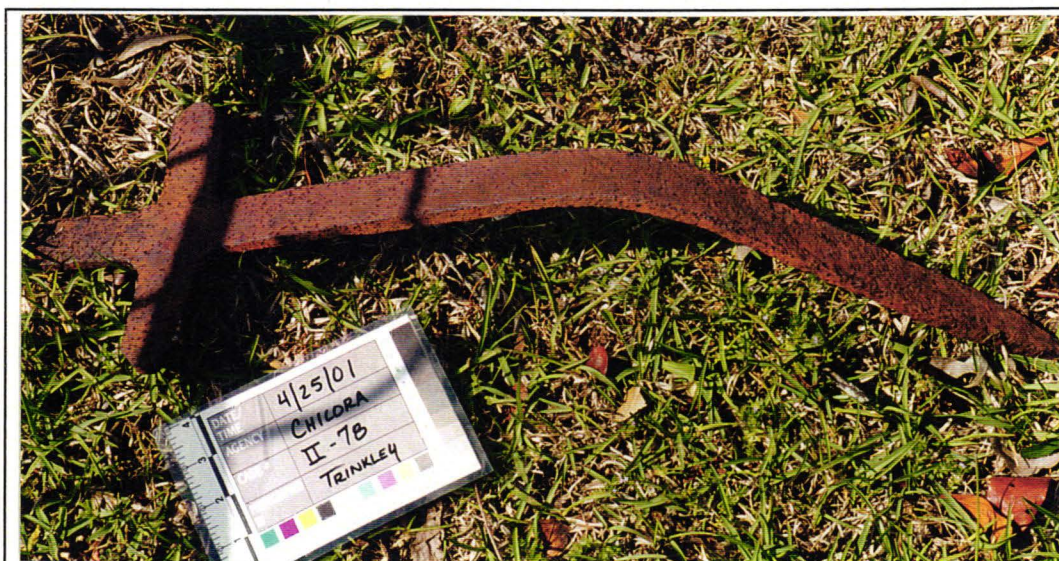
Figure 48. Iron cross found in plot II-78. Steps should be taken to immediately secure this unusual grave marker.

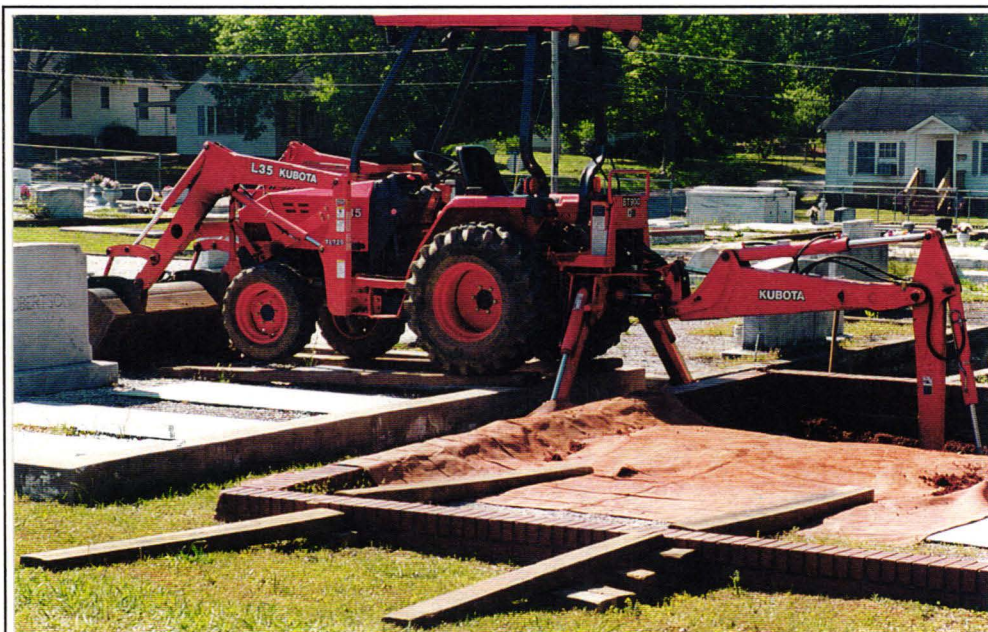
Figure 49. Example of complex arrangements necessary to allow a backhoe to be used for the excavation of graves at Glenwood. Because damage to the historic markers will eventually occur, we recommend that only hand excavation and filling of graves be allowed.
